## Address-Level Effects in Aguadilla, Puerto Rico, from the 1918 $M_w$ 7.3 Earthquake and Tsunami

by Roland LaForge and William R. McCann

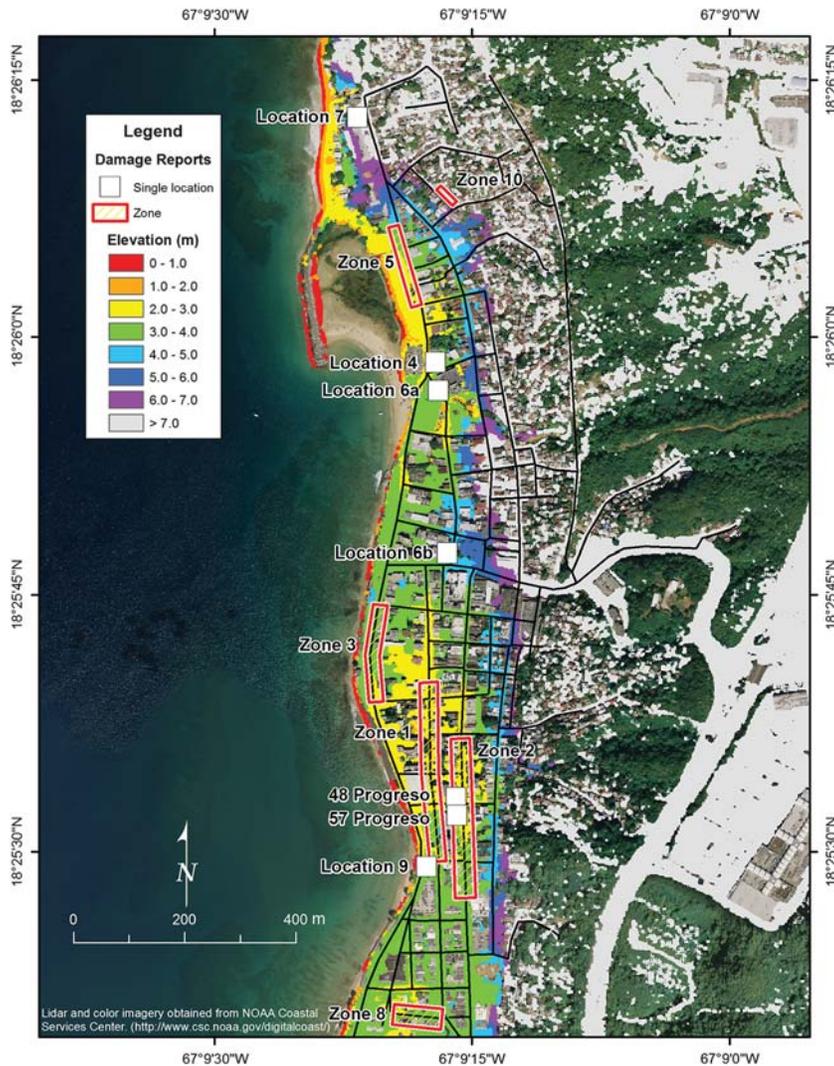
▲ **Figure 2.** Damage summary and elevations for Aguadilla.

Location 4 is explicitly at the corner of Stahl and Fósforo. The two-story mamposteria (unreinforced masonry) structure was rendered uninhabitable by ground shaking, but there is no mention of tsunami inundation. At location 6a or 6b, another large mamposteria structure was damaged, but judged repairable. Again, no tsunami damage was noted. If street numbers on Calle de la Fuente increased to the south, this implies a location very close to location 4. Alternatively, this location could be at the south end of Calle de la Fuente. This is possible, because location 4 is in Barrio Tamarindo whereas location 6 is in Barrio Iglesia, which is to the south of Barrio Tamarindo. Therefore, the 6b location in Figure 2 is considered more likely.

Zone 5 attempts to encompass the address 58 Calle Stahl. This older larger house was severely damaged, but deemed repairable for \$248. The kitchen and dining room at the rear (beach side) of the house disappeared, but apparently enough of the house was left to reconstruct it.

Location 7 is the beach area between the Lafayette School and the Cemetery. Houses here were completely destroyed and carried away by the tsunami.

Zone 10 attempts to encompass a report from Calle Ceiba, where a wood house was destroyed by ground shaking. The zone conforms to the hill to the rear of the house in the damage petition, as observed in present-day topography.

Zone 8 lies about 100 m south of Calle Sol, on Calle Hernán Cortés. Today, this street is 50 m long and in the same location as in 1918. A report for a larger wooden house with kitchen on the back indicates it was severely damaged, but repairable. There is no mention of tsunami damage.

Location 6 in Figure 2 apparently sustained no tsunami damage. This location corresponds to a specific address, 3 Calle de la Fuente. If this location is on the north end of Calle de la Fuente its elevation is 2–3 m; if on the south end it would be 4–5 m. As discussed above, location 6b is considered more likely. Location 4, precisely located at the intersection of Calles Stahl and Fósforo, is in the 3–4 m range and did not mention tsunami damage. The house at address 58 Calle Stahl, represented by zone 5 (exact location unknown, but north of Calle Fósforo), faced east and had its back to the shoreline. The report states that the kitchen and dining room at the back of the house were destroyed by the tsunami, with much structural damage to the rest of the house although the house was repairable. Because the precise dimensions and construction of this house were documented, it may prove valuable in estimating the physical characteristics of the tsunami as it hit this location, which is at an elevation of 3–4 m.

To the south, zones 1 and 2 show progressive tsunami effects from west to east. Along Calle Betances (zone 1), which lies 30–70 m from the shoreline, houses closest to the beach were totally destroyed, while those to the north were knocked off their foundations and pushed inland. The house with the lowest address number, probably in the northern part of zone 1, though severely damaged, did not mention tsunami effects. Figure 5, a photo taken looking south from the south end of Calle Betances, shows what houses along the street looked like, albeit 20 years before the earthquake. Some of the Betances damage reports may be for houses shown in this photo.

Along Calle Progreso about 50 m to the east (zone 2), and about 70 m from the shoreline, the tsunami reached its maximum inland extent. At 48 Progreso (Fig. 3), water damage was claimed, but because the inspector could not detect it after the owner repaired the damage, it must have been minimal. At 56 Progreso, the inspector claimed the water came up to within 6 ft of the house, and denied a claim for water damage. At 57 Progreso (Fig. 3), water carried away clothing and furniture. At 61 Progreso, no damage was detected, and the claim was denied. These reports clearly identify this localized area as where the extent of inundation was reached, in this part of town. The area lies 70–80 m from the shoreline, and at an elevation of no more than 4 m.

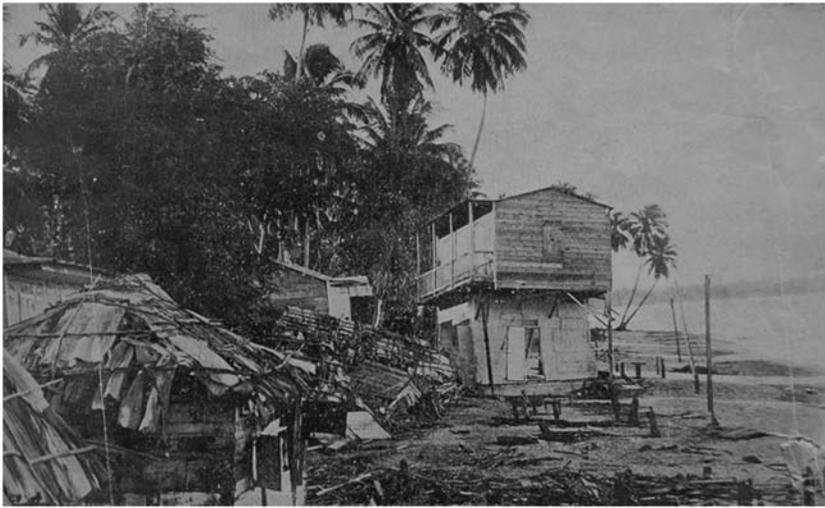
▲ **Figure 4.** Photo from Puerto Rico Ilustrado number 452, showing shoreline damage near zone 3 in Figure 2.

the structure remaining. Figure 4, from Puerto Rico Ilustrado issue number 452, shows shoreline damage in the La Ñamera district, whose exact location is unknown, but from the shoreline in the background is probably near where modern Calle Rogelio Castro (Fig. 3) meets the sea. Evident from this photo is that some houses were knocked of their stilt foundations, but they remained more or less intact and could be moved back to their original locations, as confirmed in some of the damage reports. Another observation is that palm groves and other vegetation

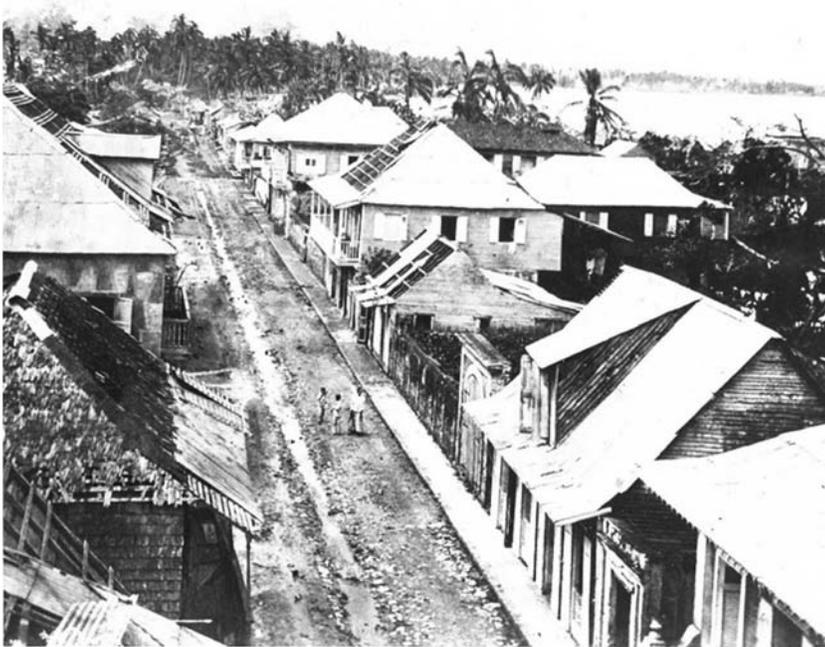
Figure 5 is an 1899 photo looking south from the southern end of Calle Betances, probably from near Calle Concepción. It gives an idea of architectural styles and building practices of this neighborhood, albeit 20 years before the earthquake. The photo was probably taken to show roof damage due to a severe hurricane of that year.

▲ **Figure 5.** Photo from San Juan archives looking south from the south end of Calle Betances (near location 9 in Fig. 2) in 1899.

along the shoreline appears to be dense and may have impeded the tsunami movement inland. Figure 5, looking south from the south end of Calle Betances, also shows dense tree and vegetation growth along the shoreline.
