Address-Level Effects in Aguadilla, Puerto Rico, from the 1918 M_w 7.3 Earthquake and Tsunami

by Roland LaForge and William R. McCann

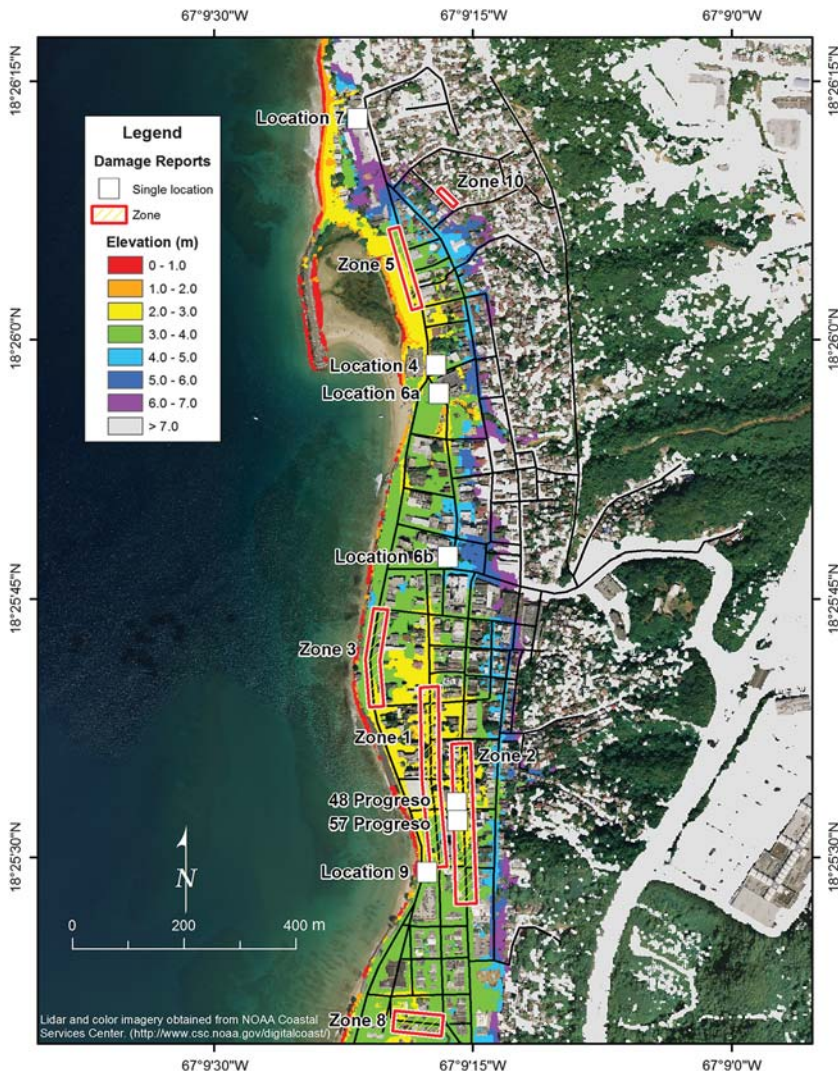
The results are presented on the map shown in Figure 2, along with the locations discussed below and in Table 3. Elevations based on light detection and ranging (lidar) data are also plotted. Figure 3 shows street names referred to.

▲ **Figure 2.** Damage summary and elevations for Agudilla.

and Calle Progreso (west to east). Along Calle Comercio, which runs along the shoreline, all petitions report complete destruction, often with the house completely carried away by the tsunami. This includes the Calle Sol reports (location 9) which are on the beach.

The second major observation is that, although limited in completeness, the reports of tsunami damage inland come from two zones: the area between Calle Stahl to the south and the Lafayette School, El Fuerte (the old Spanish fort), to the north, and the area along Calles Betances and Progreso to the south. The lidar map (Fig. 2) shows that these areas have elevations of less than 3 m. There are no reports of tsunami damage inland between these two areas, which is of higher (3–4 m) elevation, though such reports may have existed. However, a report from Calle Hernán Cortés (zone 8 in Fig. 2), in the 3–4 m elevation range, clearly indicates no tsunami effects.

Location 6 in Figure 2 apparently sustained no tsunami damage. This location corresponds to a specific address, 3 Calle de la Fuente. If this location is on the north end of Calle de la Fuente its elevation is 2–3 m; if on the south end it would be 4–5 m. As discussed above, location 6b is considered more likely. Location 4, precisely located at the intersection of Calles Stahl and Fósforo, is in the 3–4 m range and did not mention tsunami damage. The house at address 58 Calle Stahl, represented by zone 5 (exact location unknown, but north of Calle Fósforo), faced east and had its back to the shoreline. The report states that the kitchen and dining room at the back of the house were destroyed by the tsunami, with much structural damage to the rest of the house although the house was repairable. Because the precise dimensions and construction of this house were documented, it may prove valuable in estimating the physical characteristics of the tsunami as it hit this location, which is at an elevation of 3–4 m.

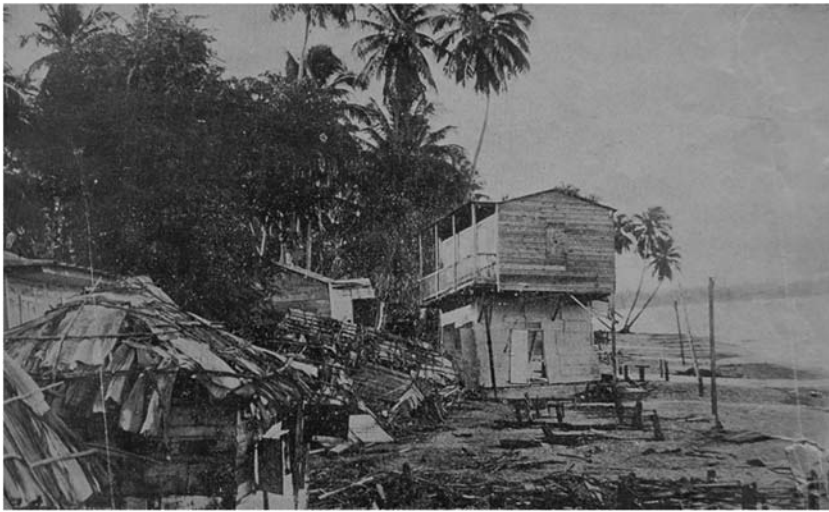
▲ **Figure 4.** Photo from Puerto Rico Ilustrado number 452, showing shoreline damage near zone 3 in Figure 2.

the structure remaining. Figure 4, from Puerto Rico Ilustrado issue number 452, shows shoreline damage in the La Ñamera district, whose exact location is unknown, but from the shoreline in the background is probably near where modern Calle Rogelio Castro (Fig. 3) meets the sea. Evident from this photo is that some houses were knocked off their stilt foundations, but they remained more or less intact and could be moved back to their original locations, as confirmed in some of the damage reports. Another observation is that palm groves and other vegetation

along the shoreline appears to be dense and may have impeded the tsunami movement inland. Figure 5, looking south from the south end of Calle Betances, also shows dense tree and vegetation growth along the shoreline.

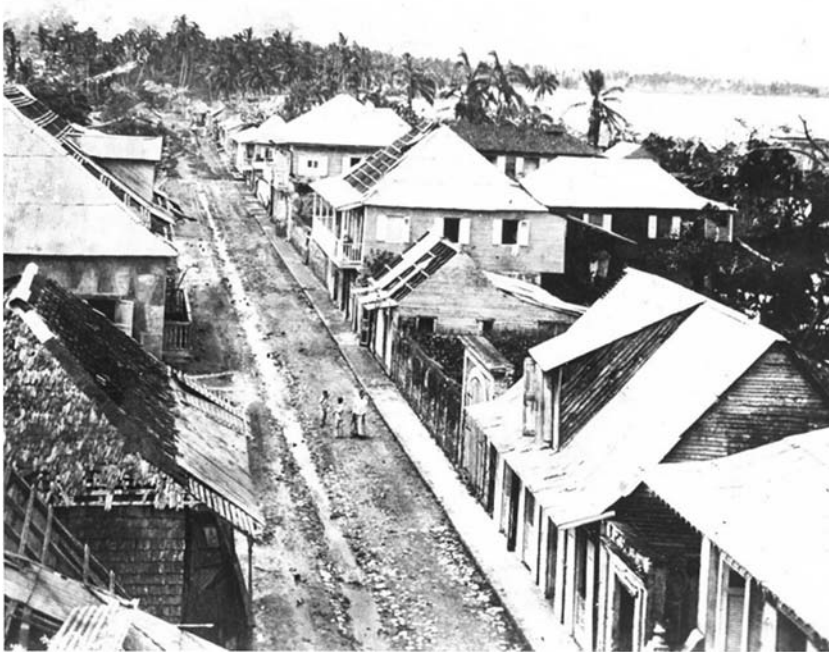
Figure 5 is an 1899 photo looking south from the southern end of Calle Betances, probably from near Calle Concepción. It gives an idea of architectural styles and building practices of this neighborhood, albeit 20 years before the earthquake. The photo was probably taken to show roof damage due to a severe hurricane of that year.

▲ **Figure 5.** Photo from San Juan archives looking south from the south end of Calle Betances (near location 9 in Fig. 2) in 1899.

To the south, zones 1 and 2 show progressive tsunami effects from west to east. Along Calle Betances (zone 1), which lies 30–70 m from the shoreline, houses closest to the beach were totally destroyed, while those to the north were knocked off their foundations and pushed inland. The house with the lowest address number, probably in the northern part of zone 1, though severely damaged, did not mention tsunami effects. Figure 5, a photo taken looking south from the south end of Calle Betances, shows what houses along the street looked like, albeit 20 years before the earthquake. Some of the Betances damage reports may be for houses shown in this photo.
