## Address-Level Effects in Aguadilla, Puerto Rico, from the 1918 $M_w$ 7.3 Earthquake and Tsunami

by Roland LaForge and William R. McCann

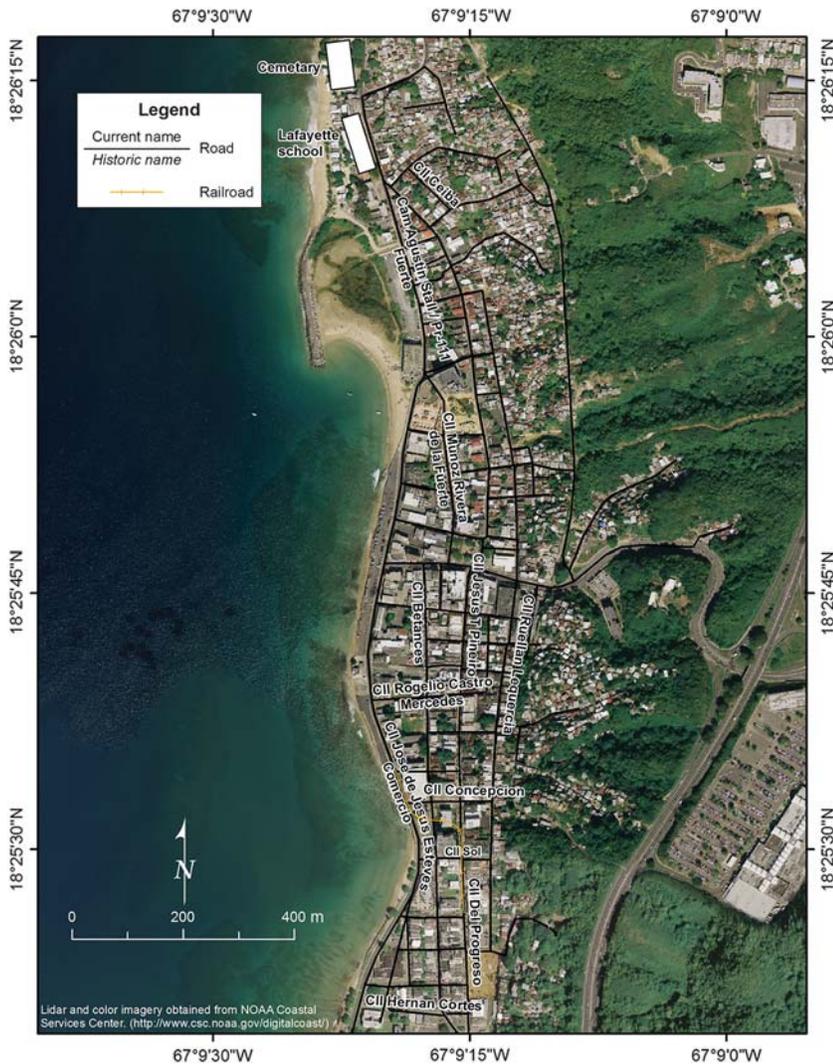
About 200 m north of this area, at 10 Calle las Mercedes (now Calle Rogelio Castro, shown in Fig. 3), a false report was filed for a small wood house; the inspector found no damage. From the old map, that street ran from the shoreline 250 m to the east, ending at present-day Calle Ruella Lequerica. The low address number implies that this location was at either the east

▲ **Figure 3.** Streets referred to in damage discussion. Note that Calle Mercedes in 1918 is now Calle Rogelio Castro, Calle Comercio is now Calle Jose de Jesus Esteves, and Calle de la Fuente is now Calle Muñoz Rivera.

Along Calle Progreso about 50 m to the east (zone 2), and about 70 m from the shoreline, the tsunami reached its maximum inland extent. At 48 Progreso (Fig. 3), water damage was claimed, but because the inspector could not detect it after the owner repaired the damage, it must have been minimal. At 56 Progreso, the inspector claimed the water came up to within 6 ft of the house, and denied a claim for water damage. At 57 Progreso (Fig. 3), water carried away clothing and furniture. At 61 Progreso, no damage was detected, and the claim was denied. These reports clearly identify this localized area as where the extent of inundation was reached, in this part of town. The area lies 70–80 m from the shoreline, and at an elevation of no more than 4 m.
